## **Windstorm Mitigation Report (OIR-B1-1802)**

9th Fairway Condominium at Green Dolphin Park, Inc.

1900 Golfview Dr, Units 1911-1948

As of 05-16-2025 | FPAT File# MUD2524788

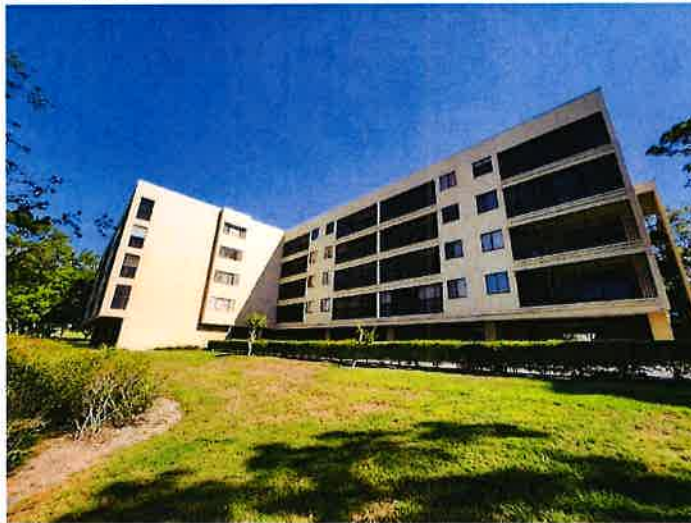
Exterior Elevation

| <b>5. Roof Geometry:</b><br>Comments: | <b>Flat Roof</b><br>Inspection verified a flat roof shape. |

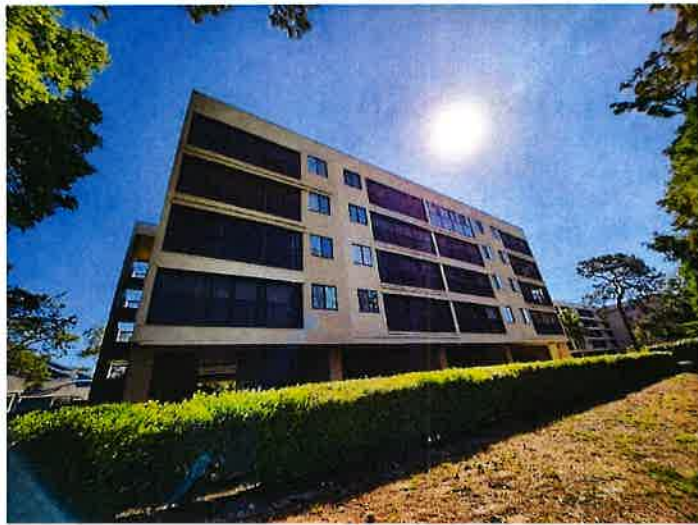
Exterior Elevation

| <b>7. Opening Protection:</b><br>Comments: | <b>None or Some Glazed Openings</b><br>No opening protection verified at time of inspection. |

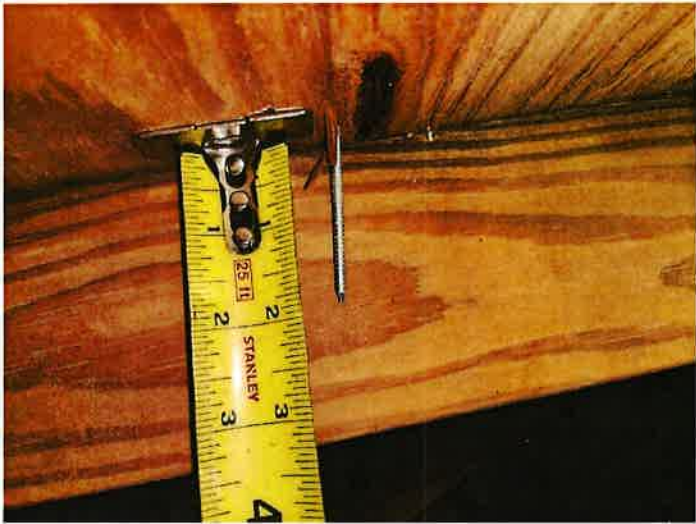
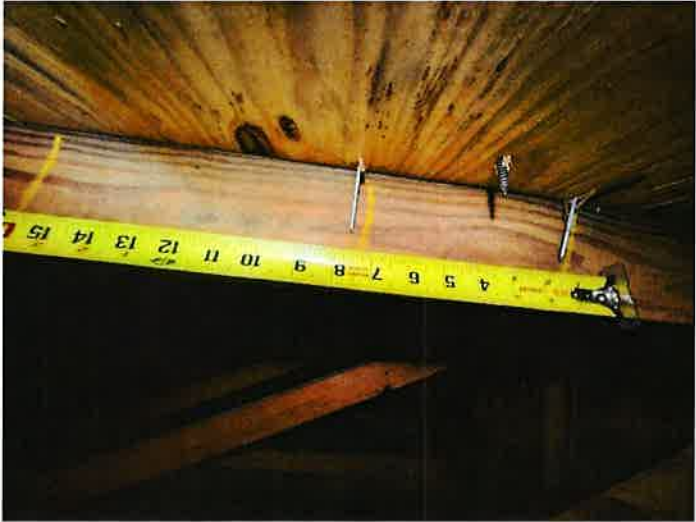
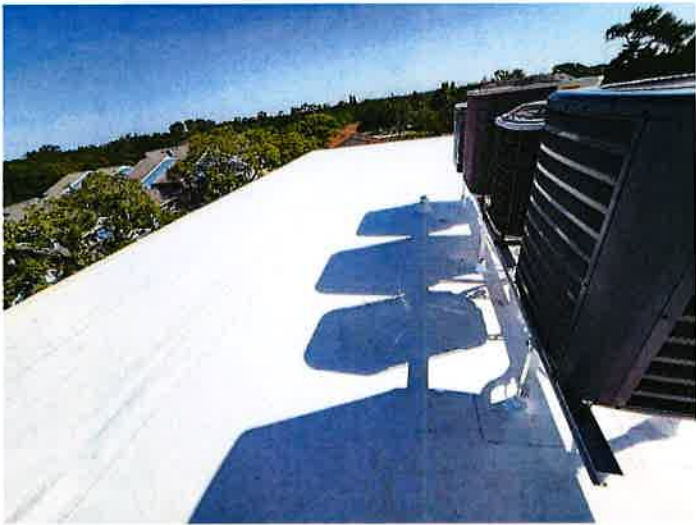
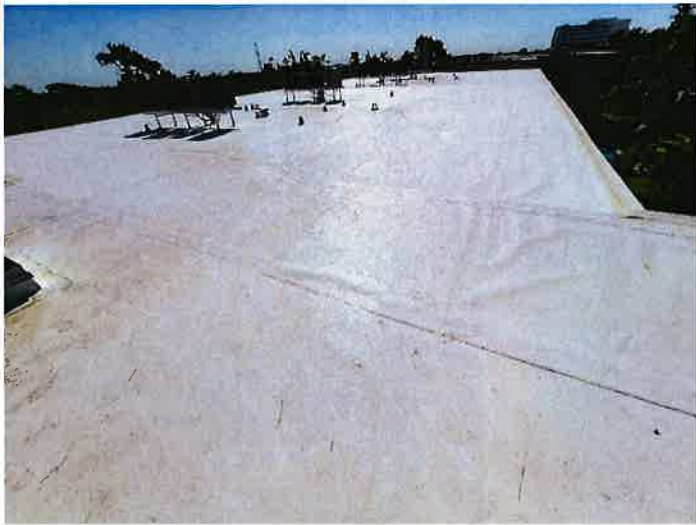
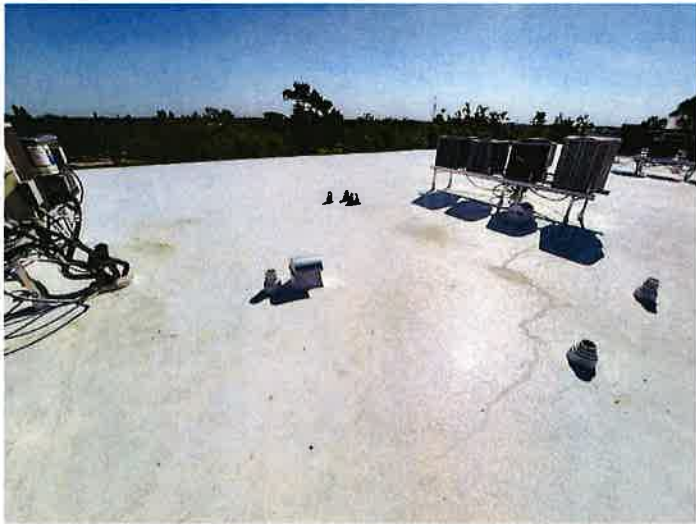
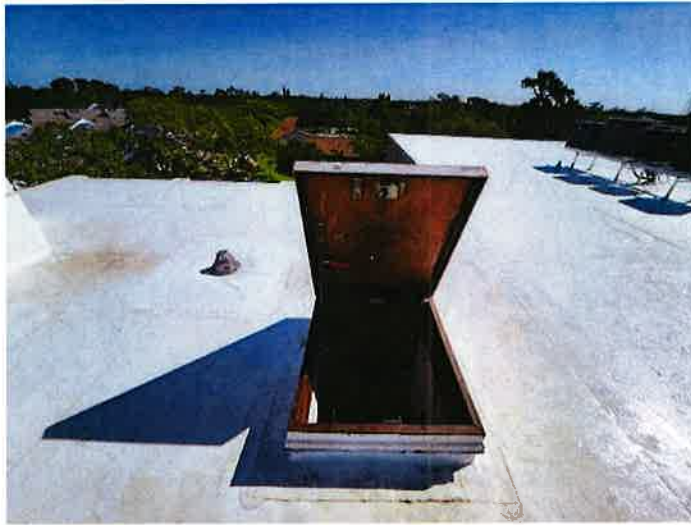
Roof Construction

| <b>3. Roof Deck Attachment:</b><br>Comments: | <b>Level B</b><br>Inspection verified 1/2" plywood roof deck attached with 8d nails at a minimum of 6" on the edge & 12" in the field. |
| <b>4. Roof to Wall Attachment:</b><br>Comments: | <b>Toe Nails</b><br>Inspection verified embedded straps fastened with less than three nails. |
